FLUTTER TESTS OF B-34 FIN-RUDDER-TAB SYSTEM

By Theodore Theodorsen and N. H. Smith

MEMORANDUM REPORT

Army Air Forces, Materiel Command

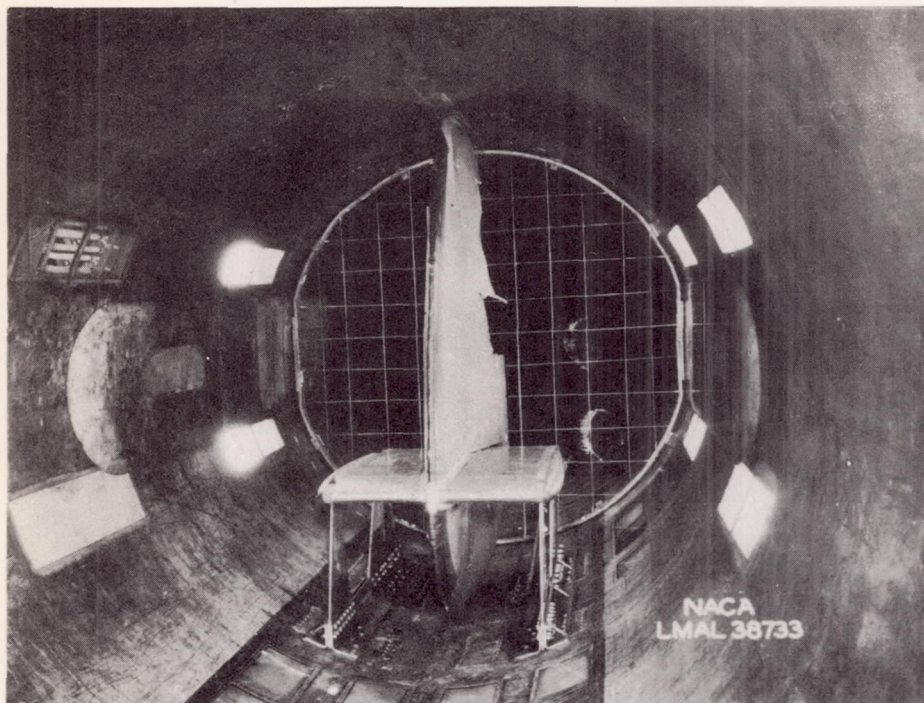
Figure 3.- Tail surface used in the tests, shown mounted on four vertical steel leaf springs in NACA 8-foot high-speed tunnel.

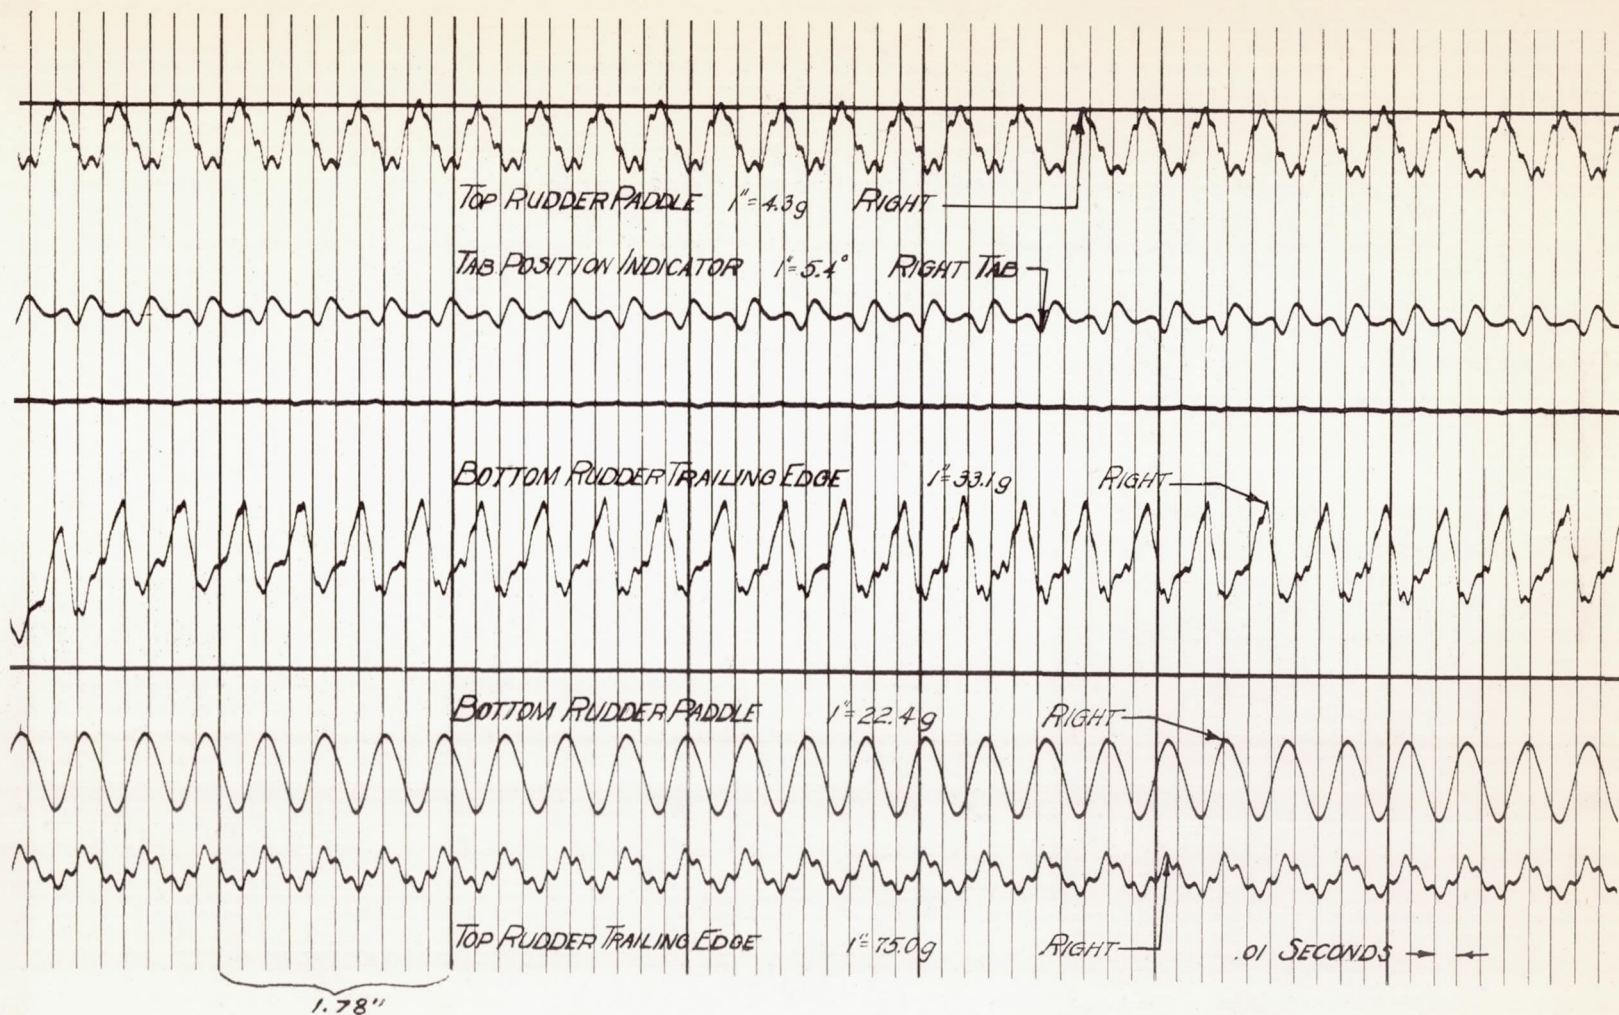
Figure 4.- Oscilloscope record with rudder-torsion shaker on lower-rudder trailing edge.
